# THERMONUCLEAR EFFECTS ON REACTIVE ARRAY RADOME MATERIALS

Rockwell International Corporation  
5701 West Imperial Highway  
Los Angeles, California 90009

1 December 1977

Final Report for Period 1 April 1977—31 November 1977

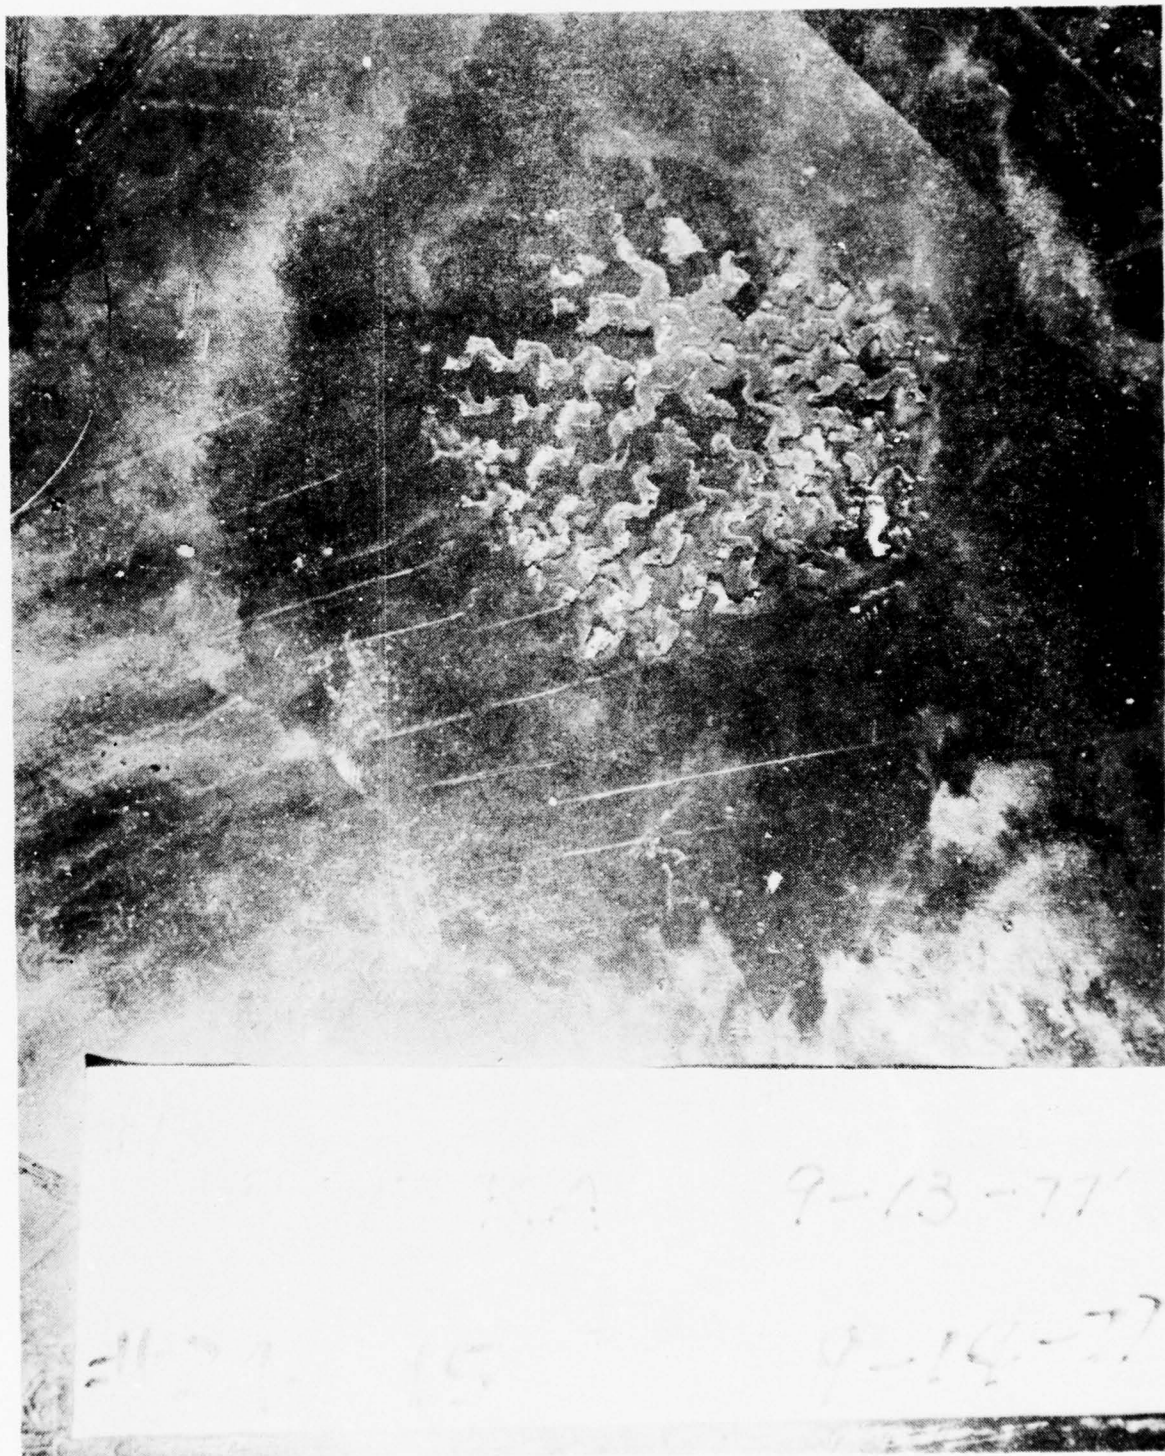
Figure 27. High coulomb restrike to 4-mil array.

Test XXIV. Utilized the panel from Test XIII. When this 0.004-inch-thick, copper-clad X-band panel was restruck in the previously damaged area, only minor metal removal was observed. This is illustrated in Figure 27. When struck in an undamaged area, only minor metal removal was evident in an area 1/4-inch long and 1/8-inch wide. No other damage was observed.

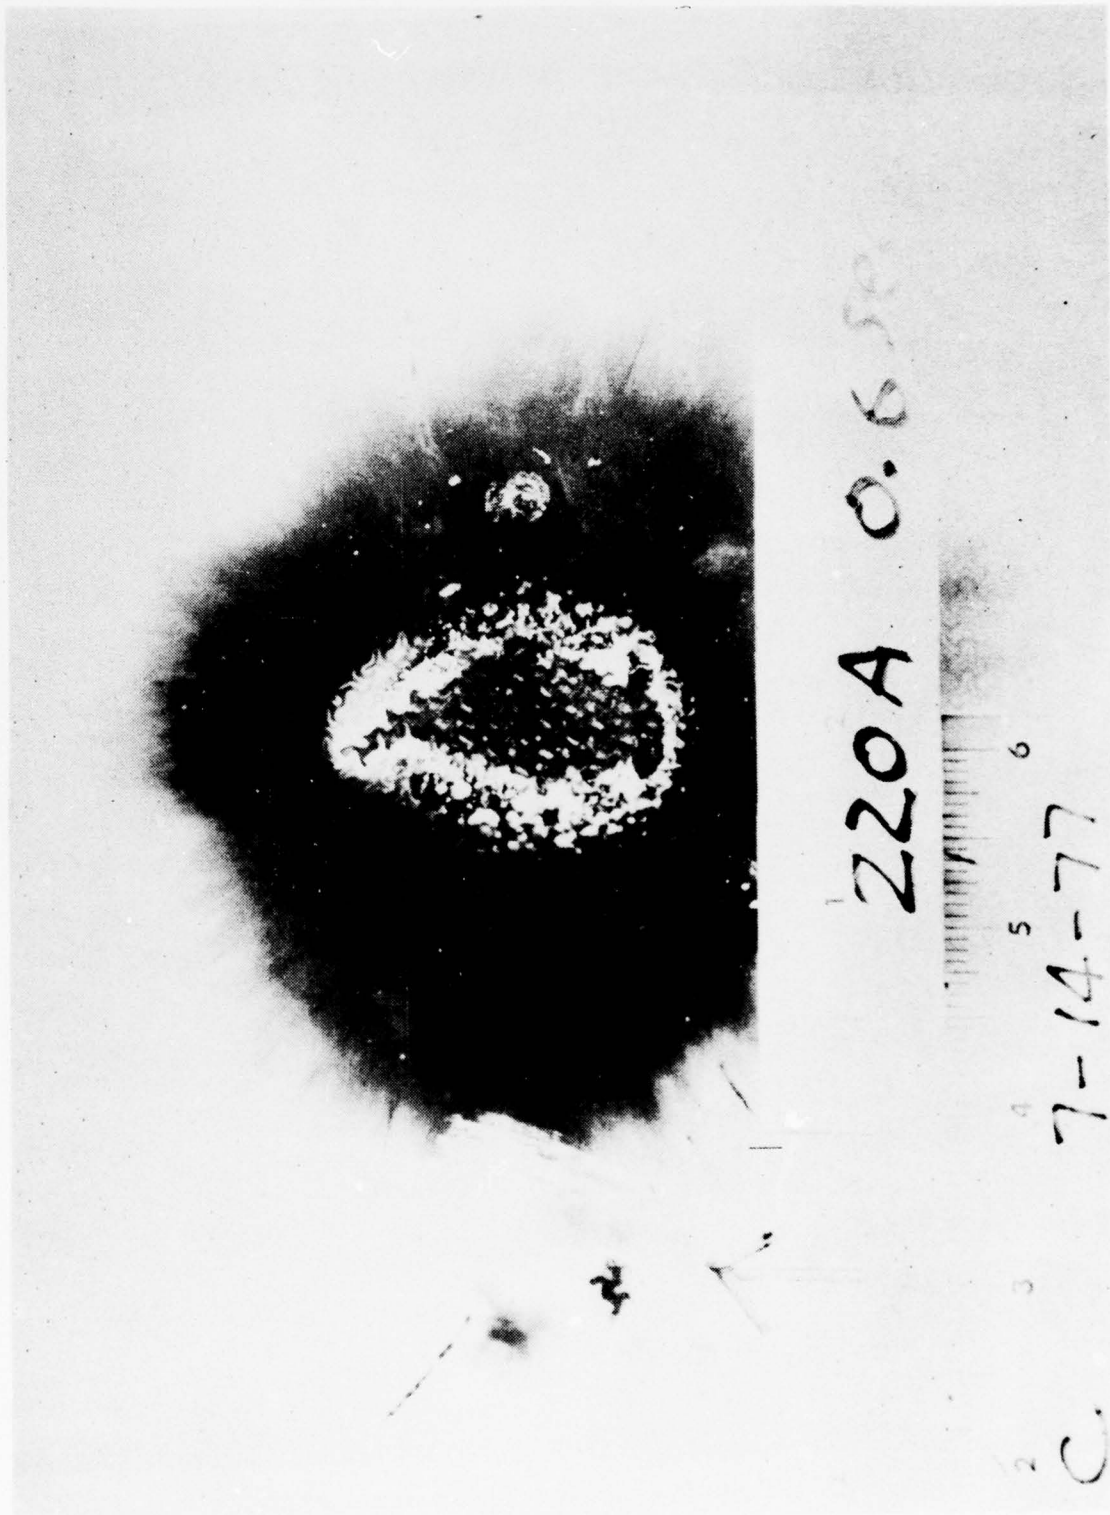
Figure 28. Long-duration discharge to 14-mil array.

Test XXV. Utilized the panel tested in series XVIII. This 0.014-inch-thick, copper-clad panel would sustain a strike for 0.6 second before termination caused by metal removal. During this period, there was severe metal damage in an area 3/4-inch wide and 1-1/4-inch long. This damage area is illustrated in Figure 28.

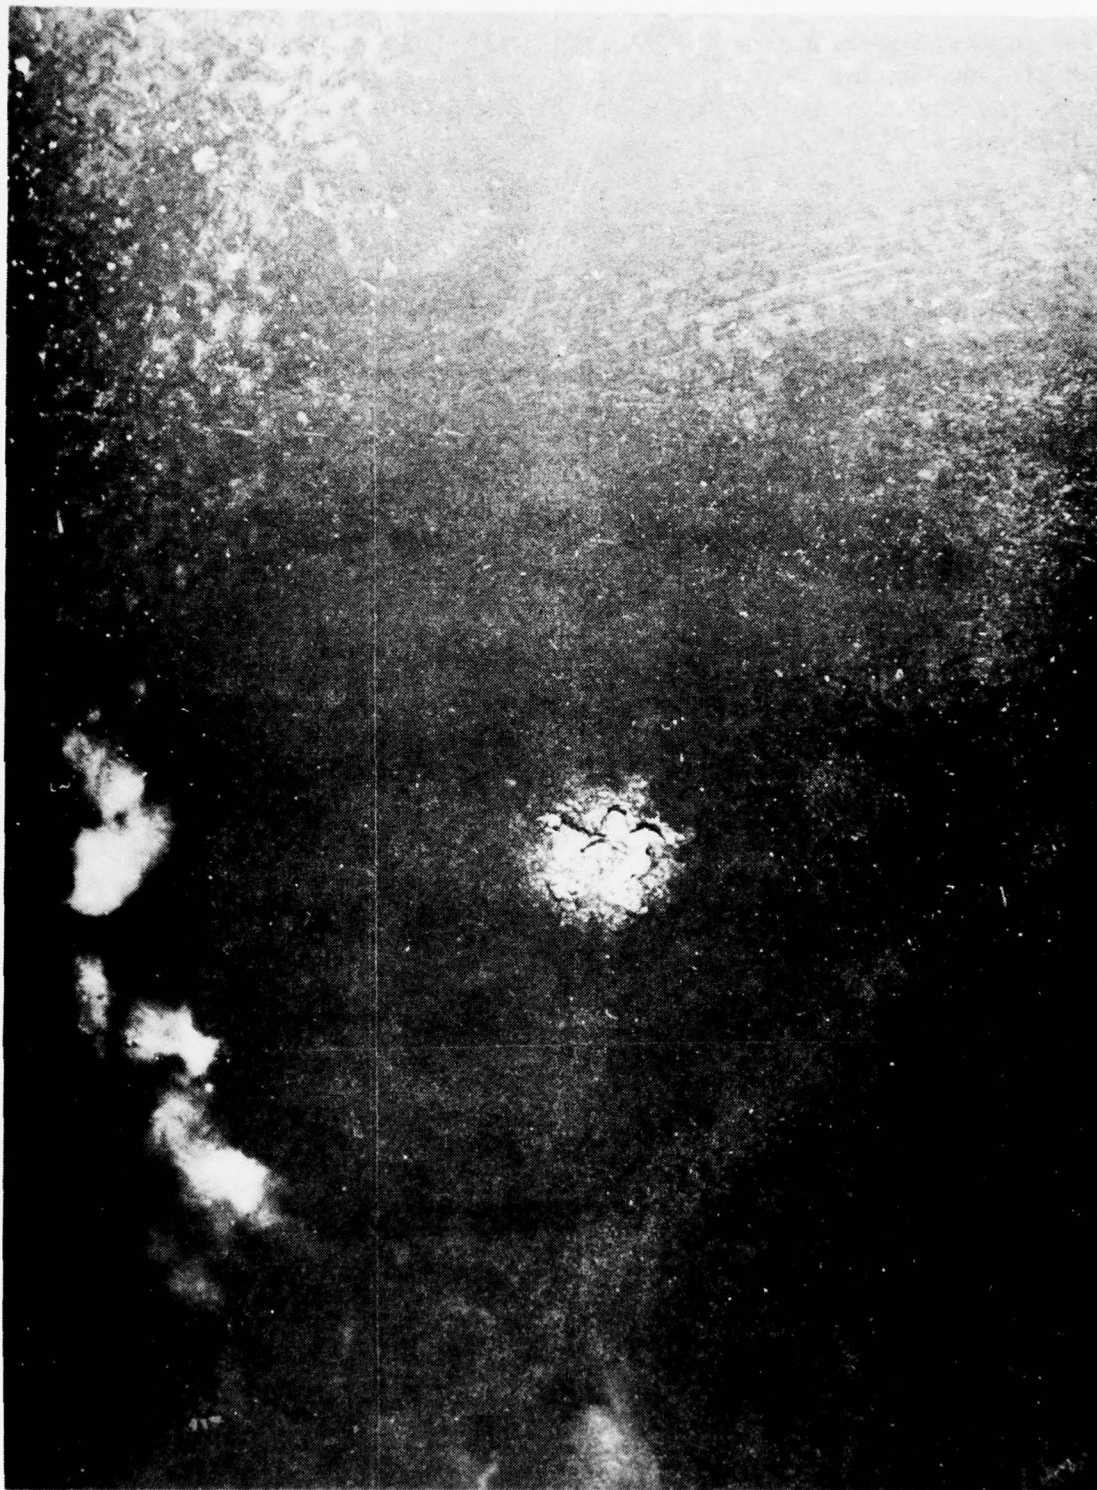
Figure 29. Composite swept stroke to 14-mil array.

Test XXIX. Ku-band array panel, 0.140-inch thick, clad with 0.014-inch-thick copper, exterior coated with 0.014-inch-thick Mil-C-83231 polyurethane rain erosion coating. On this test, the arc swept perfectly to the center of the panel, causing coating damage in a 1-inch-diameter area, and metal removal in a 1/2-inch-diameter area. As shown in Figure 29, the swept stroke damage is far less severe than the static, single-component, high-current tests.
